# Willamette Falls Fishway

THERMAL ACTION MITIGATION

PETERSON STRUCTURAL ENGINEERS

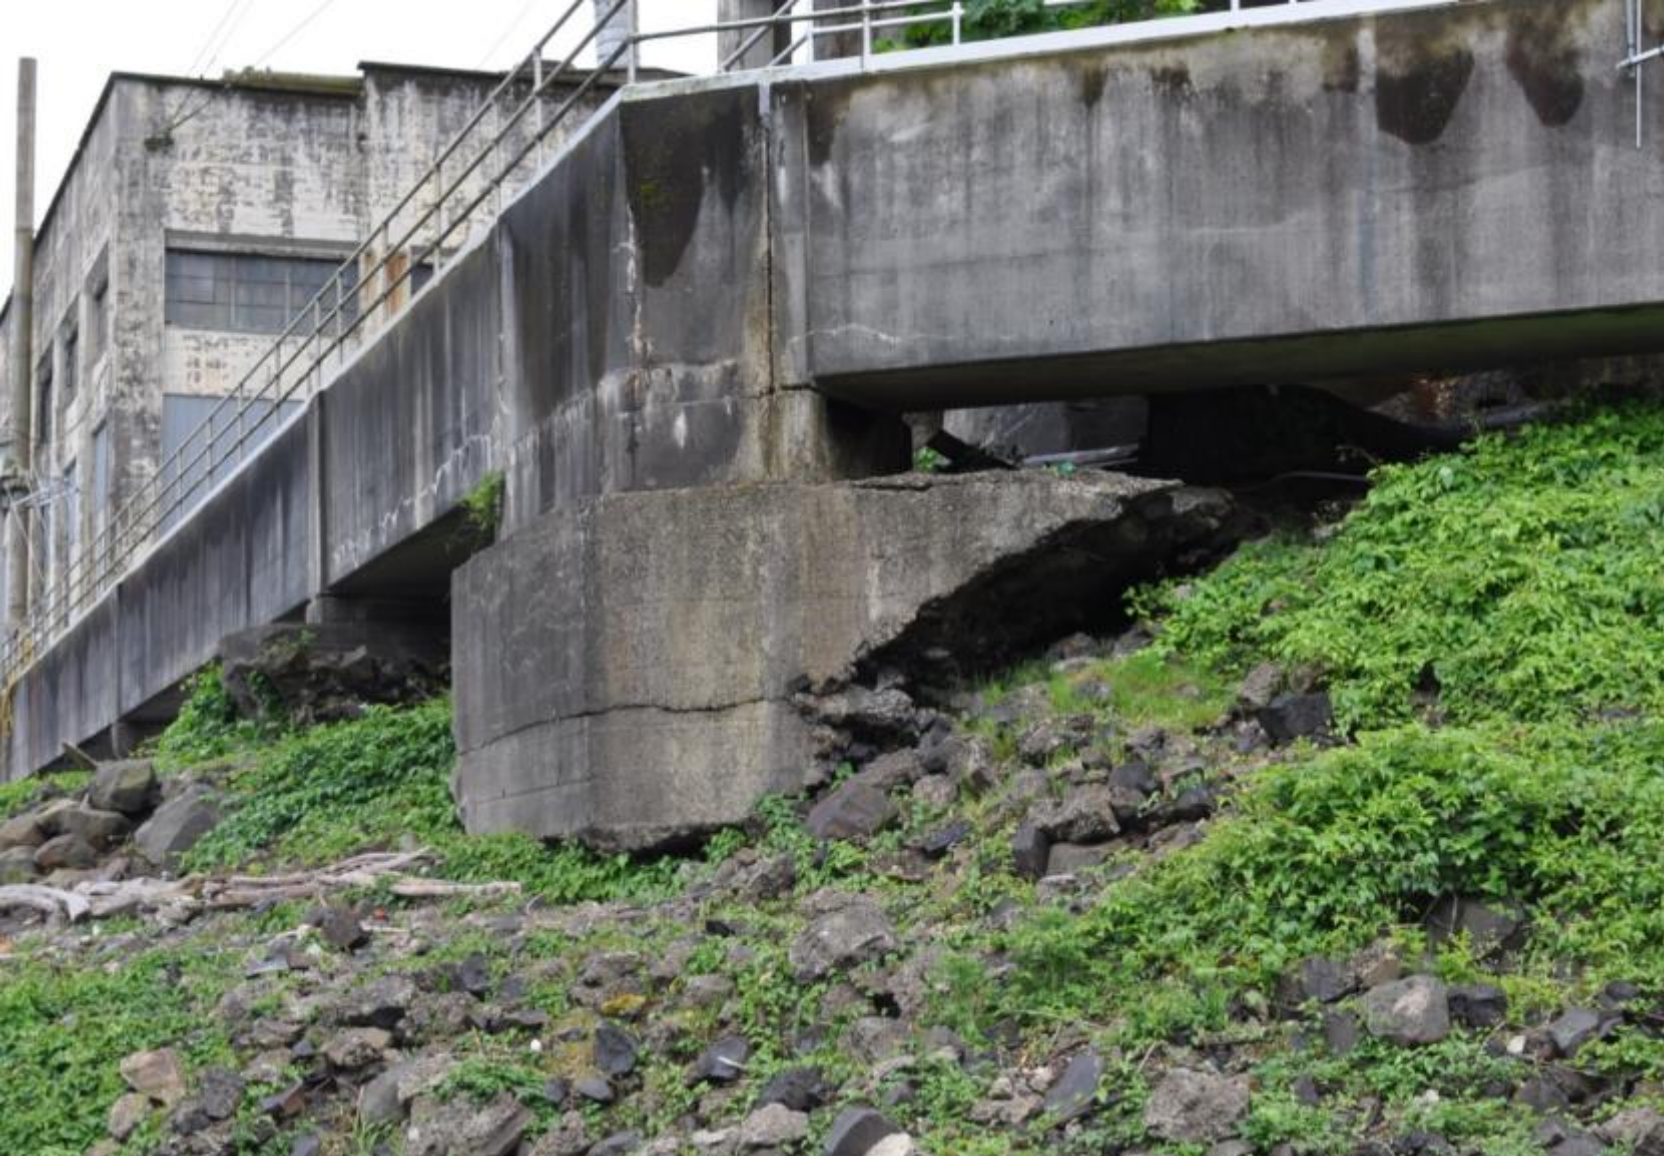
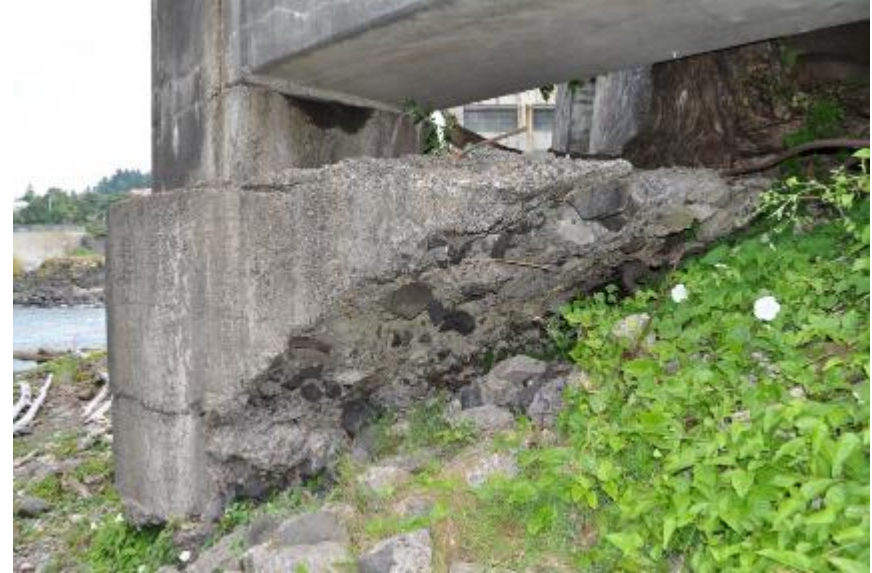
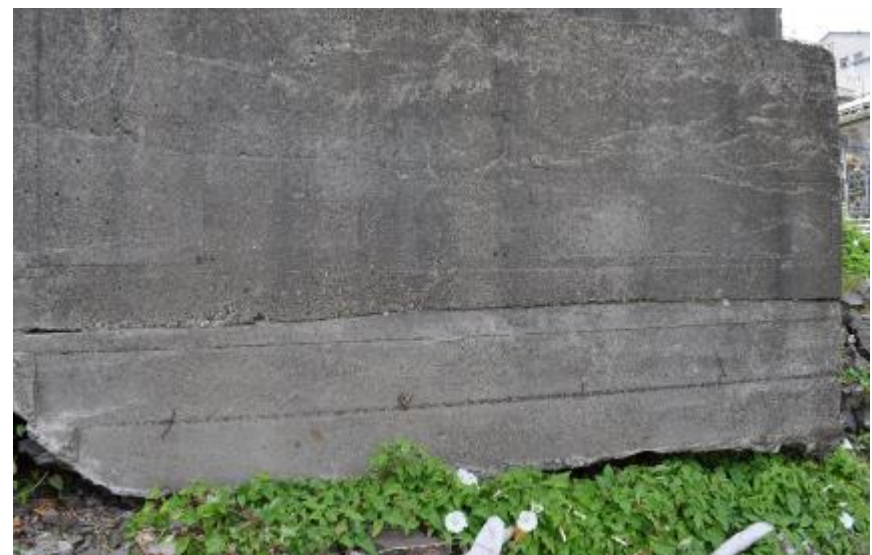
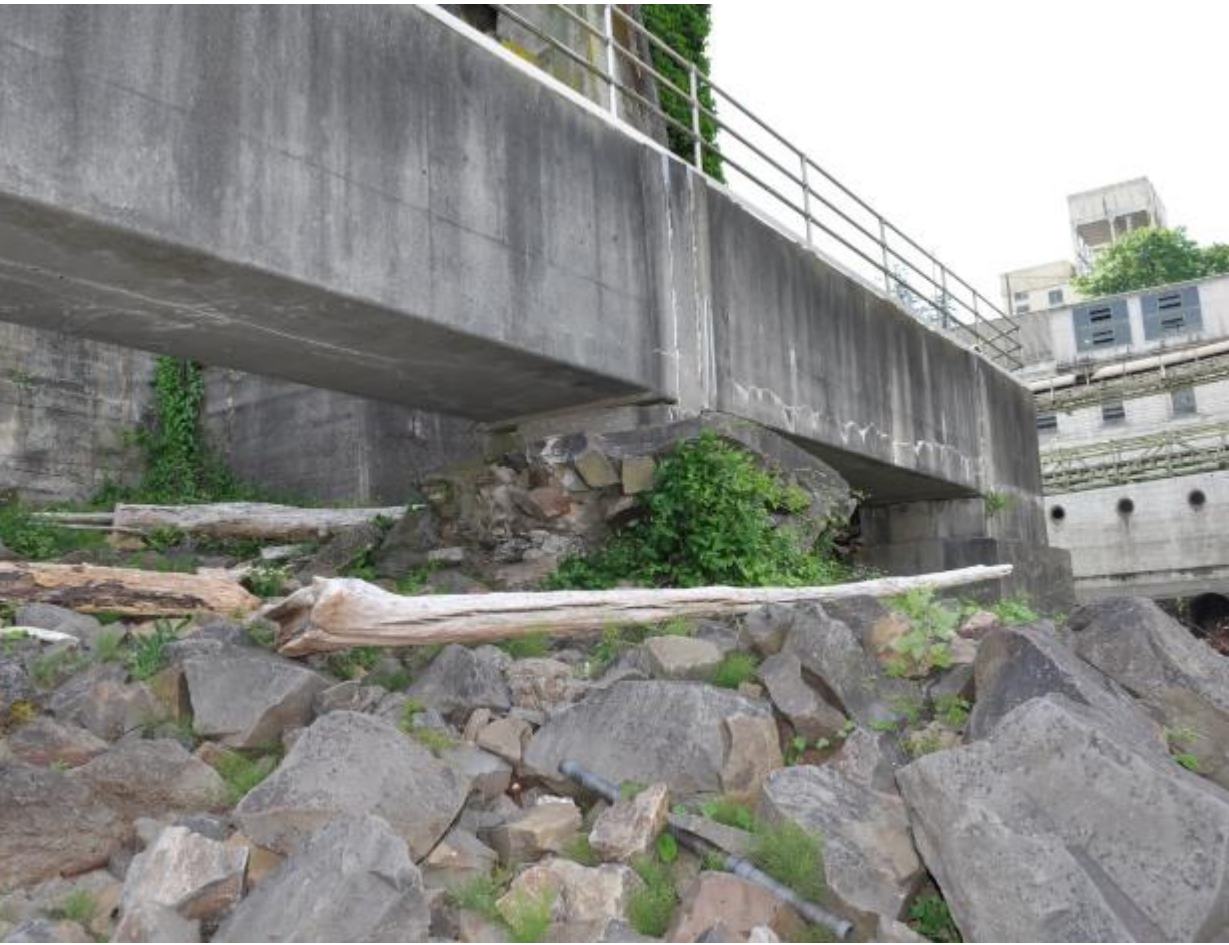
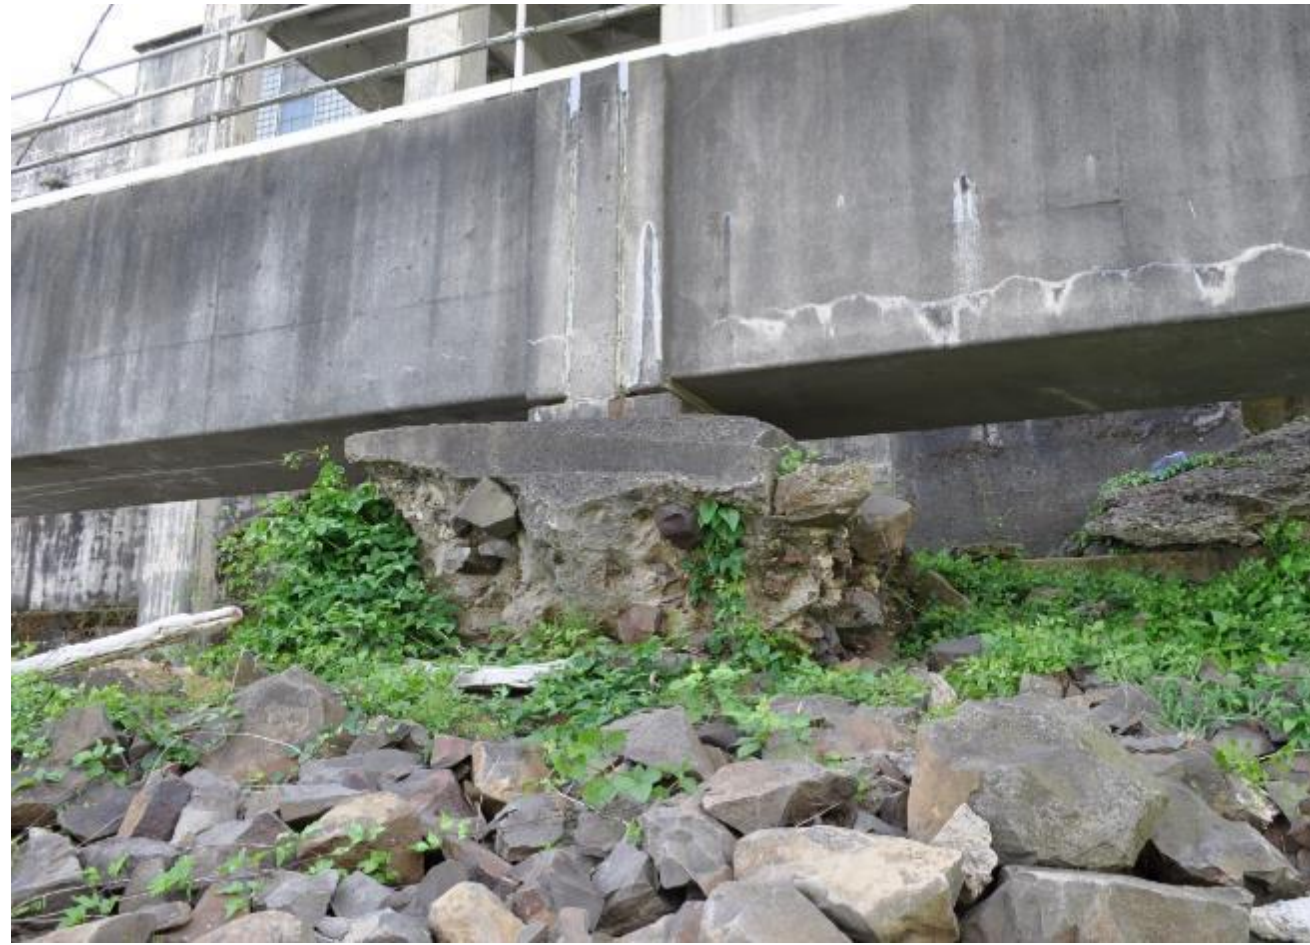
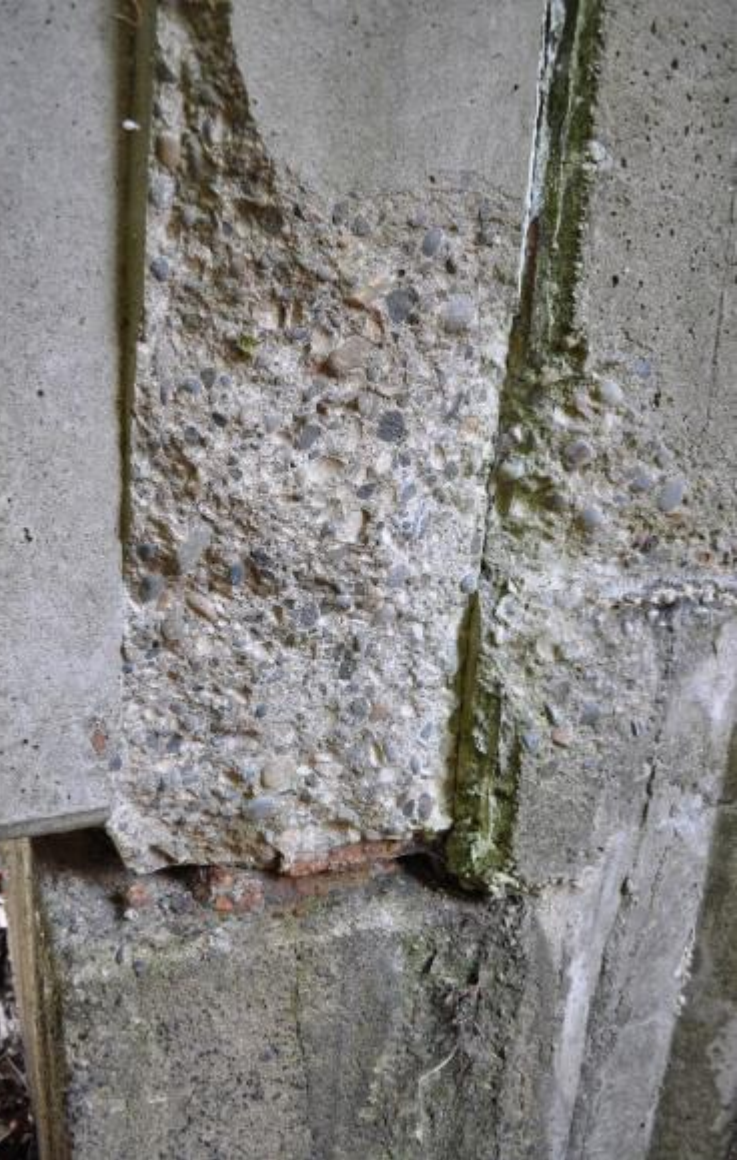
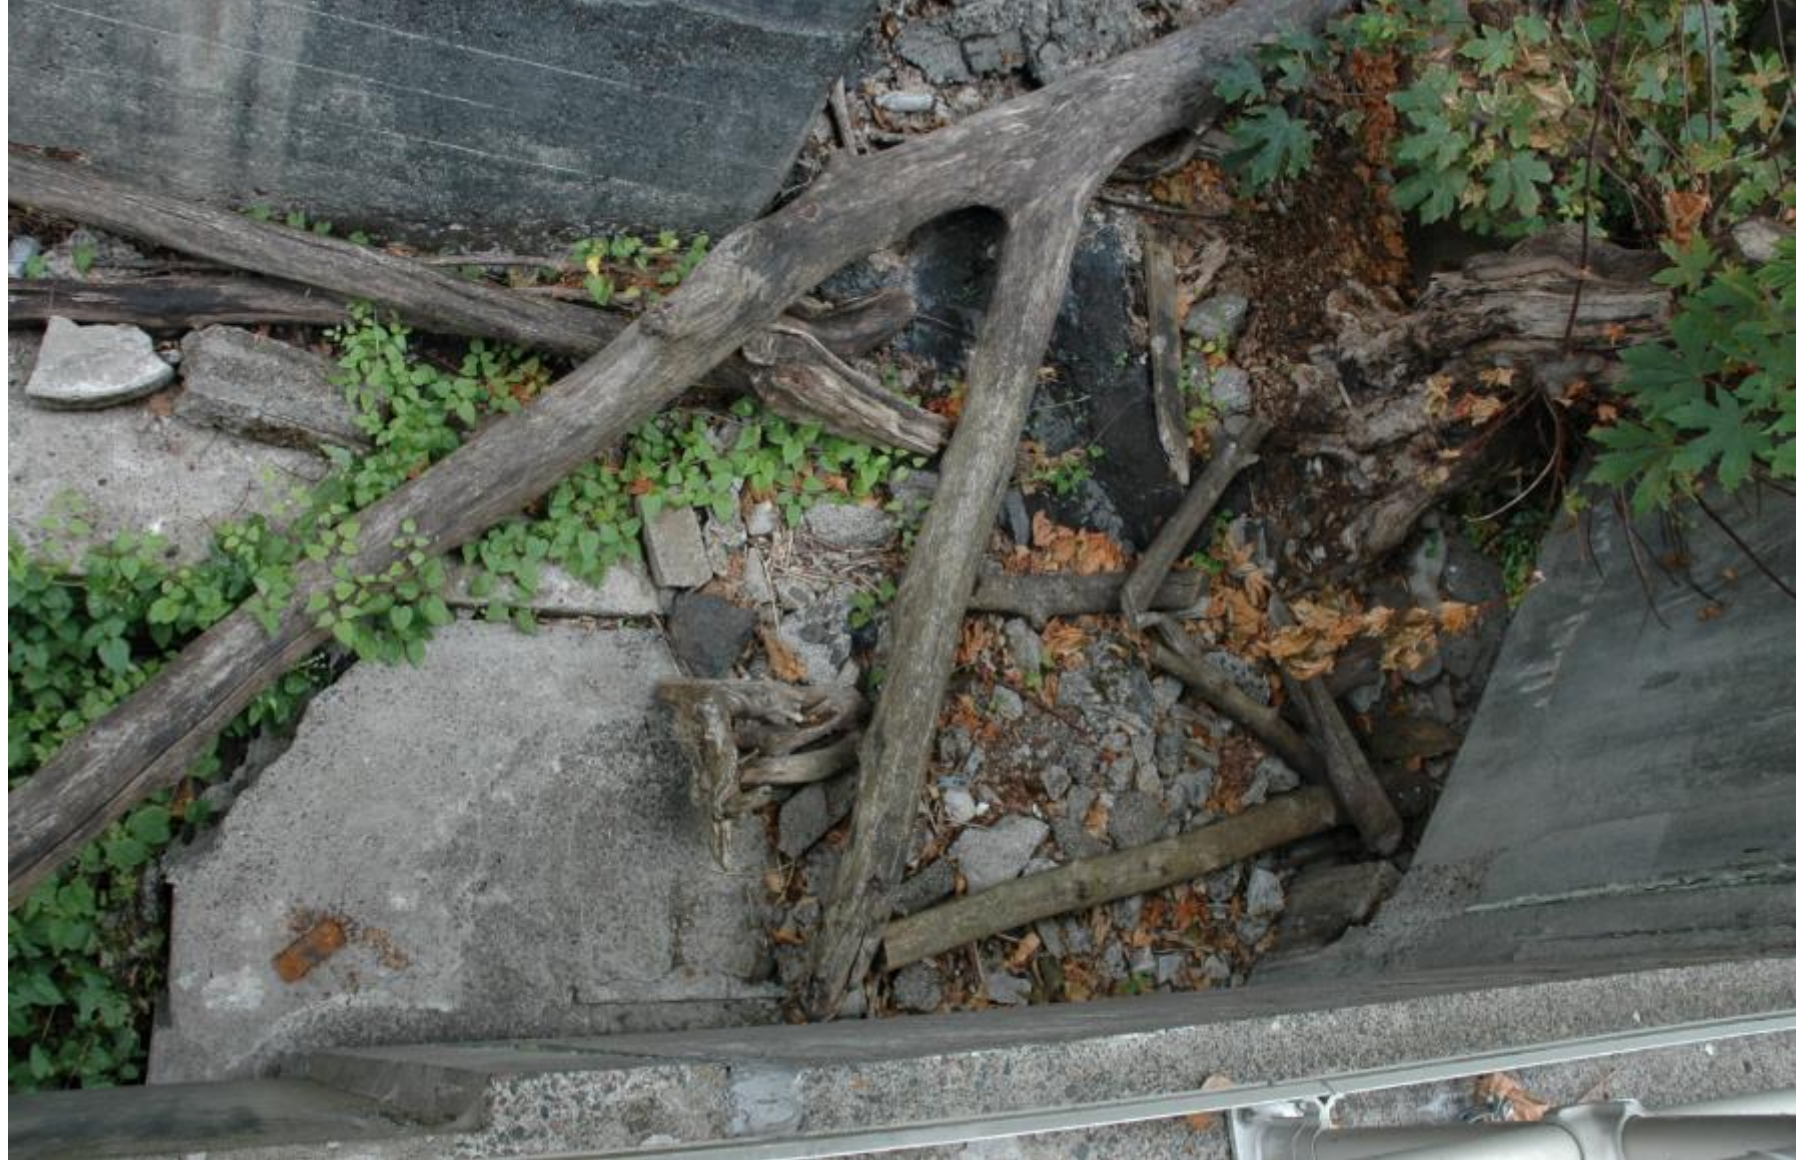
- Primary foundation issues identified:
  - Scour undermining of existing foundations
  - Expanding joints
  - Concrete spalling and structural damage

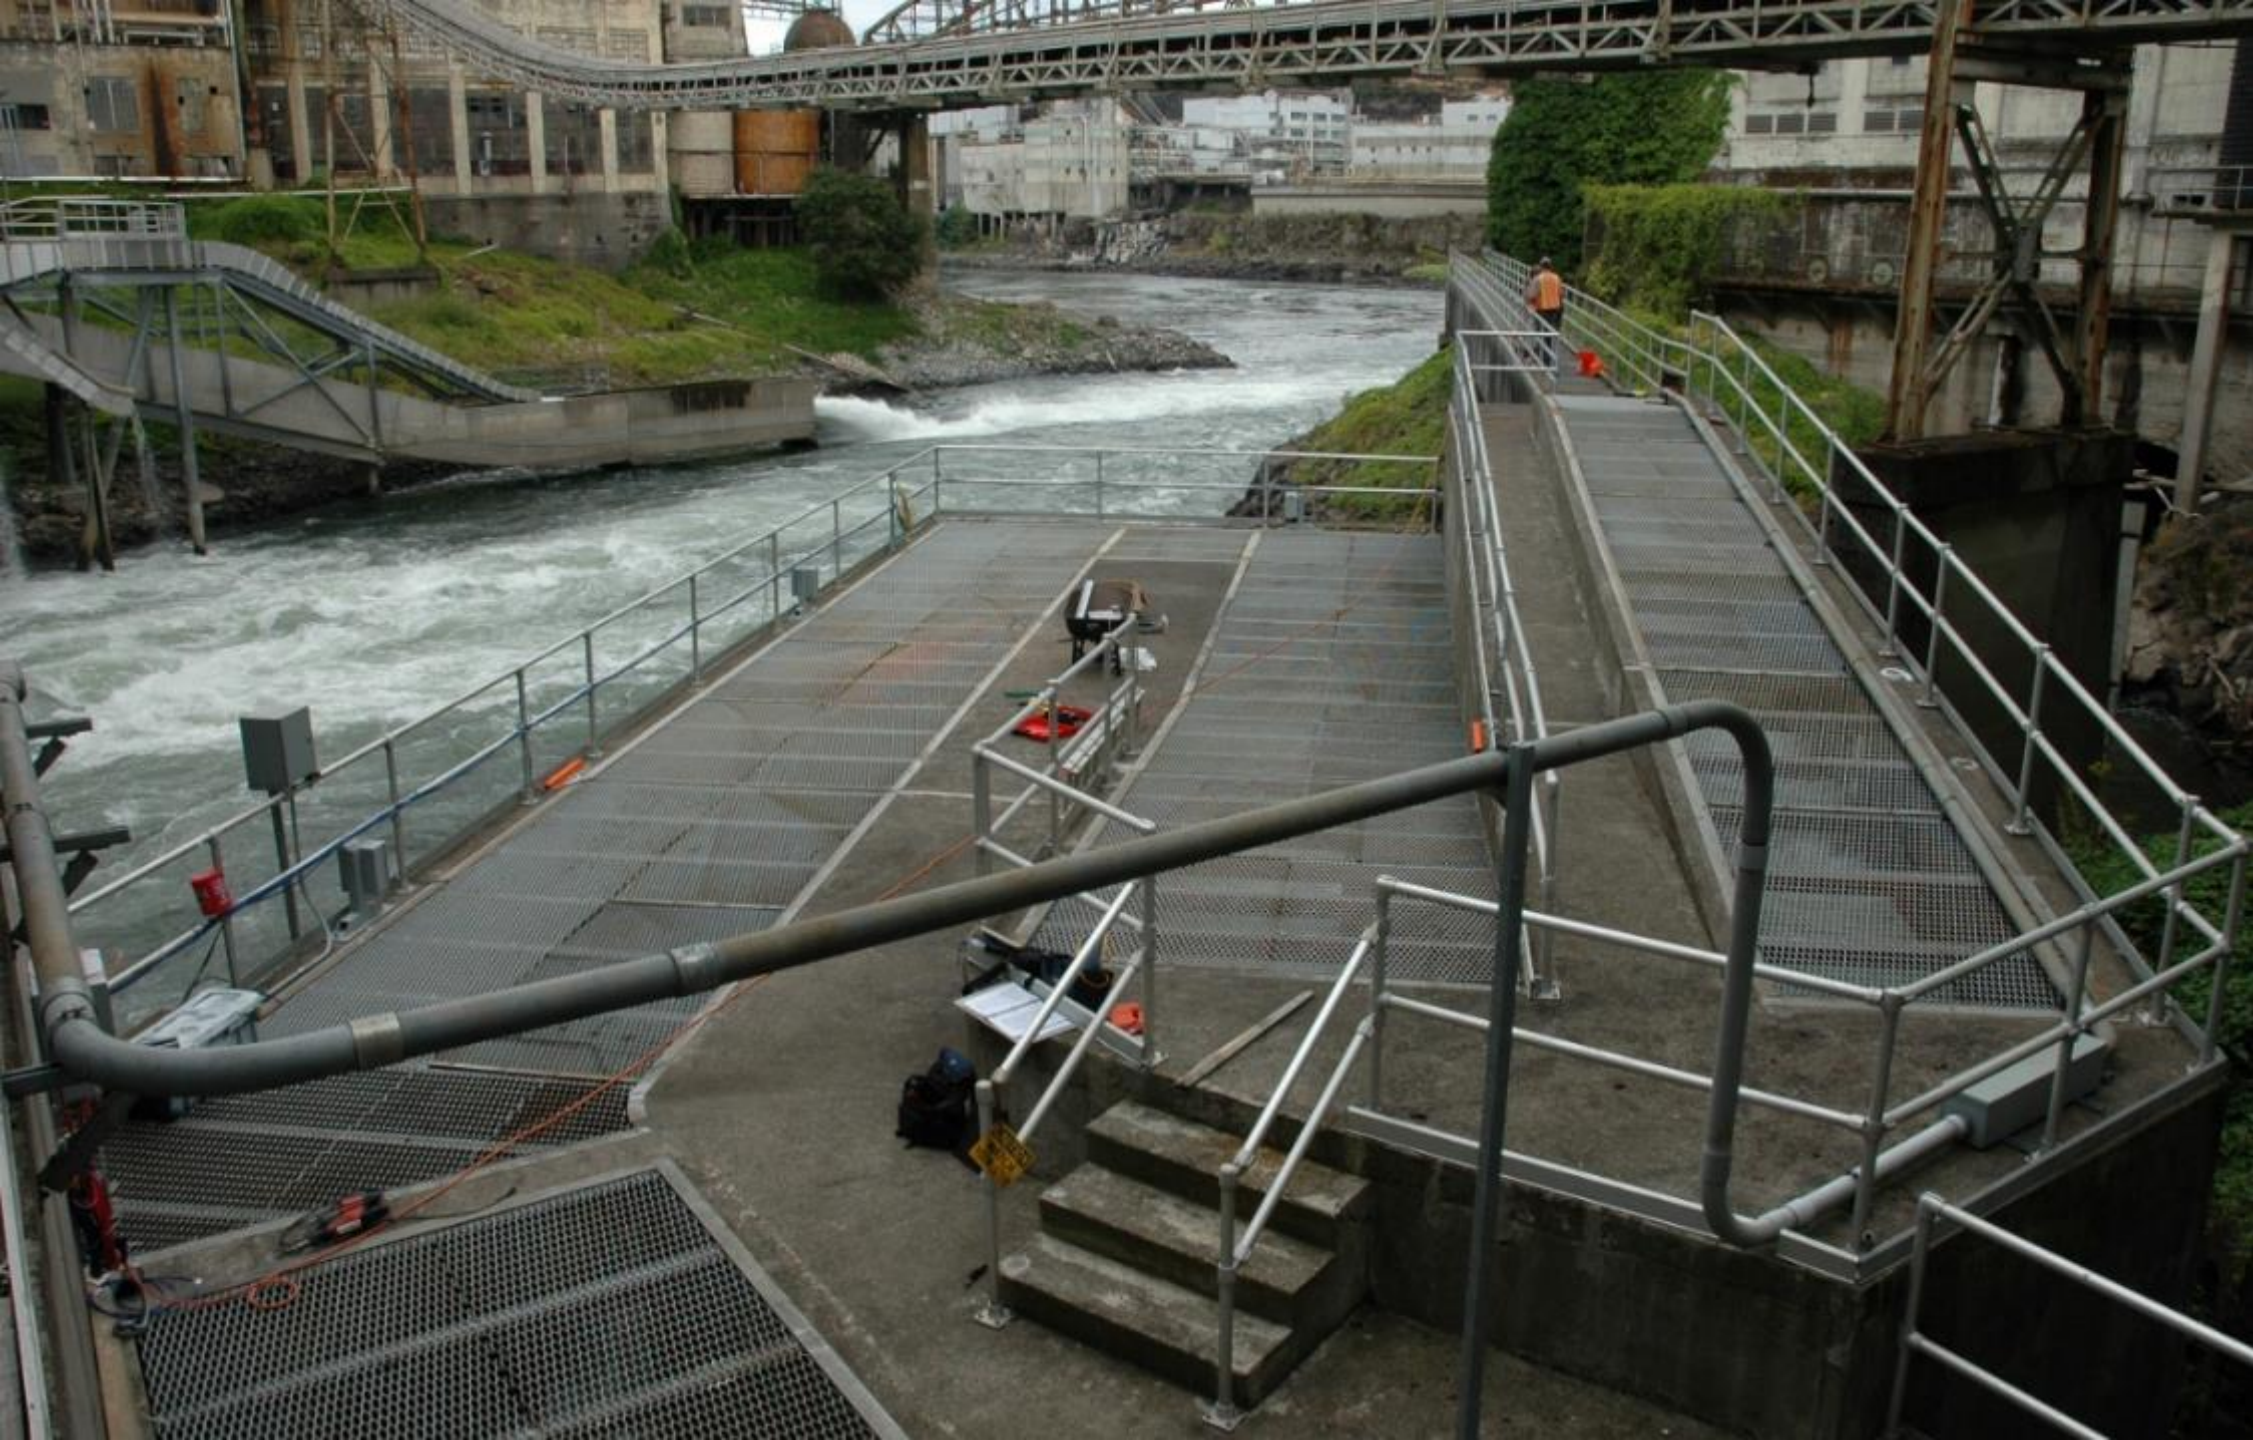
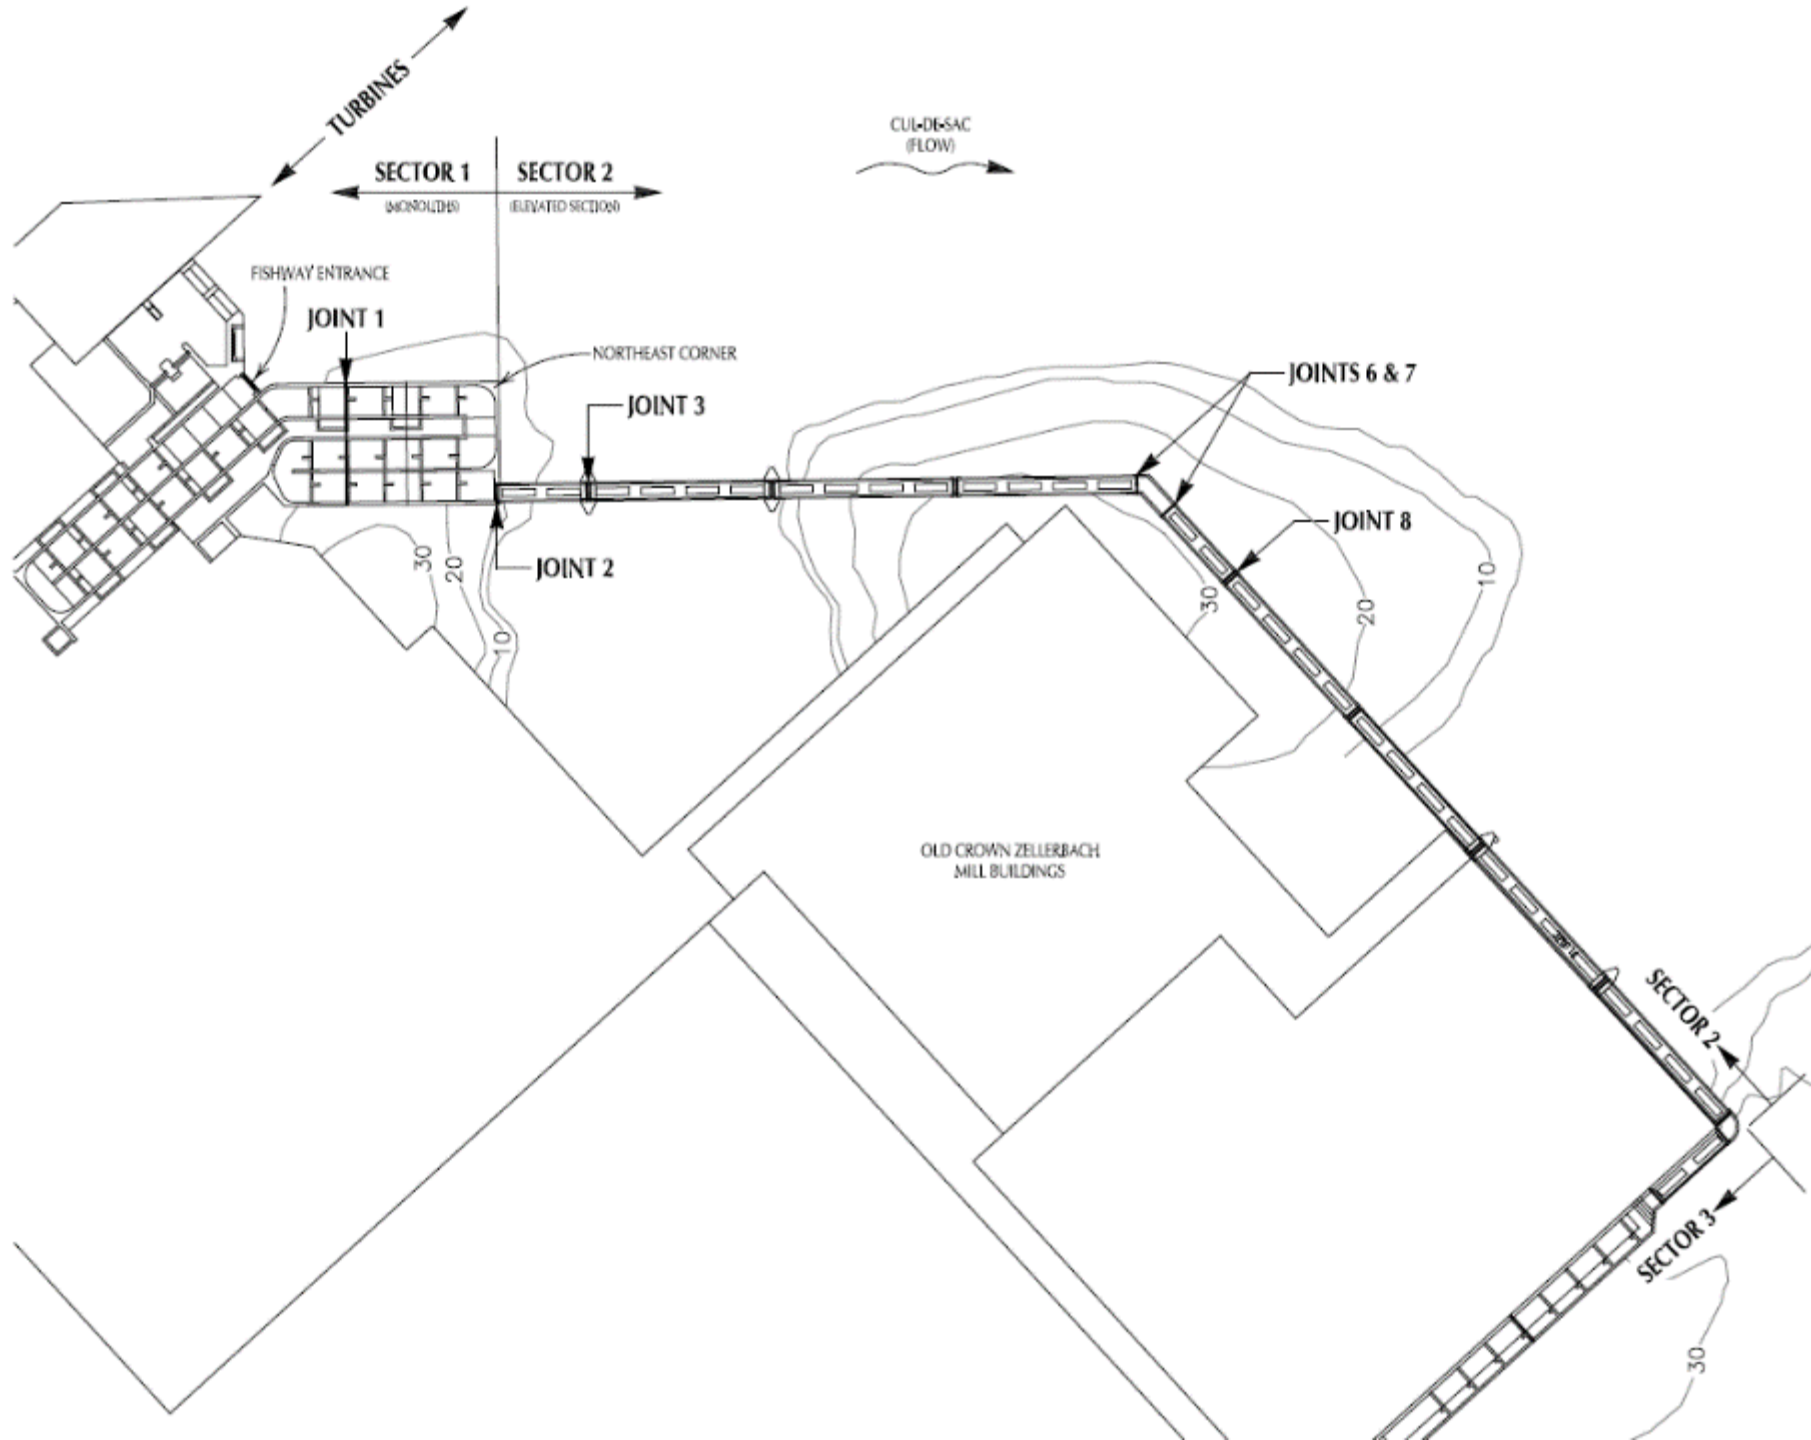
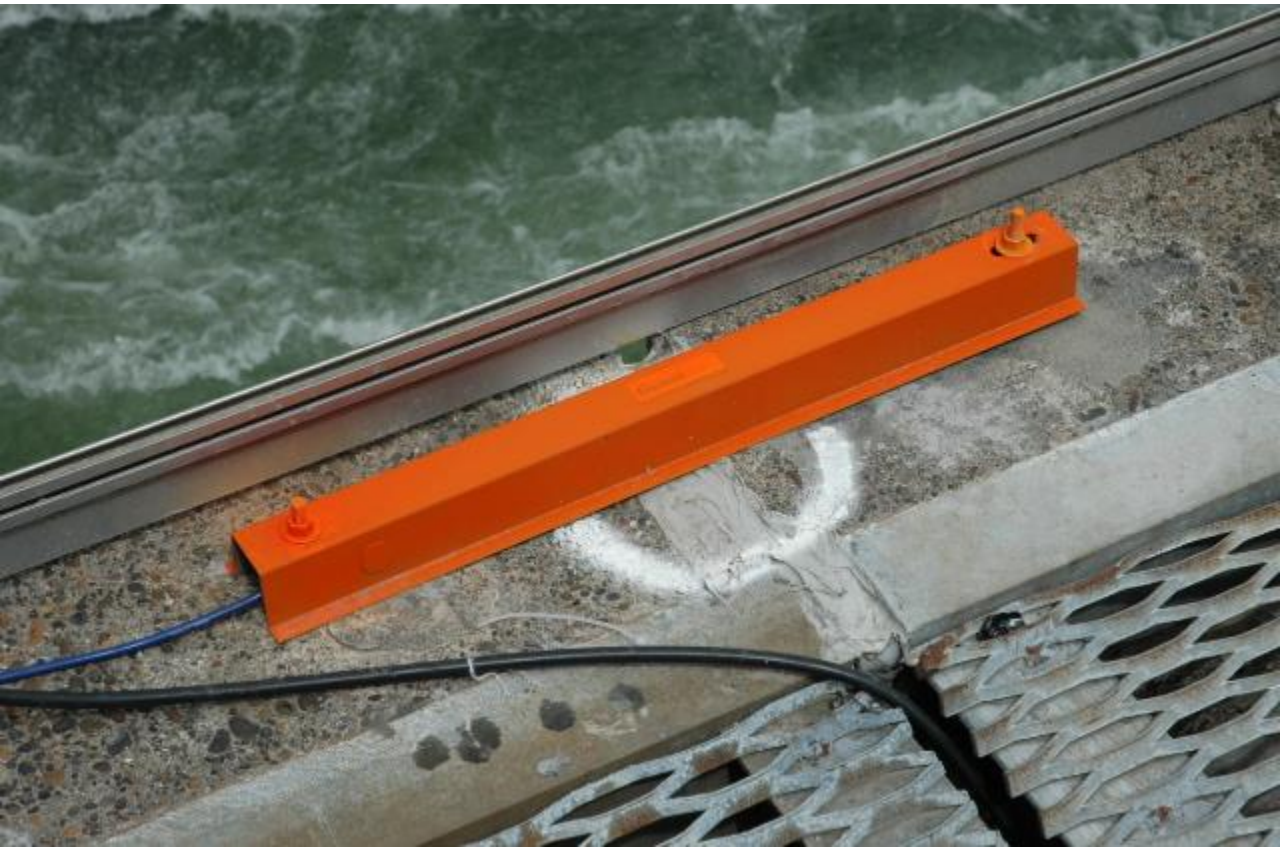
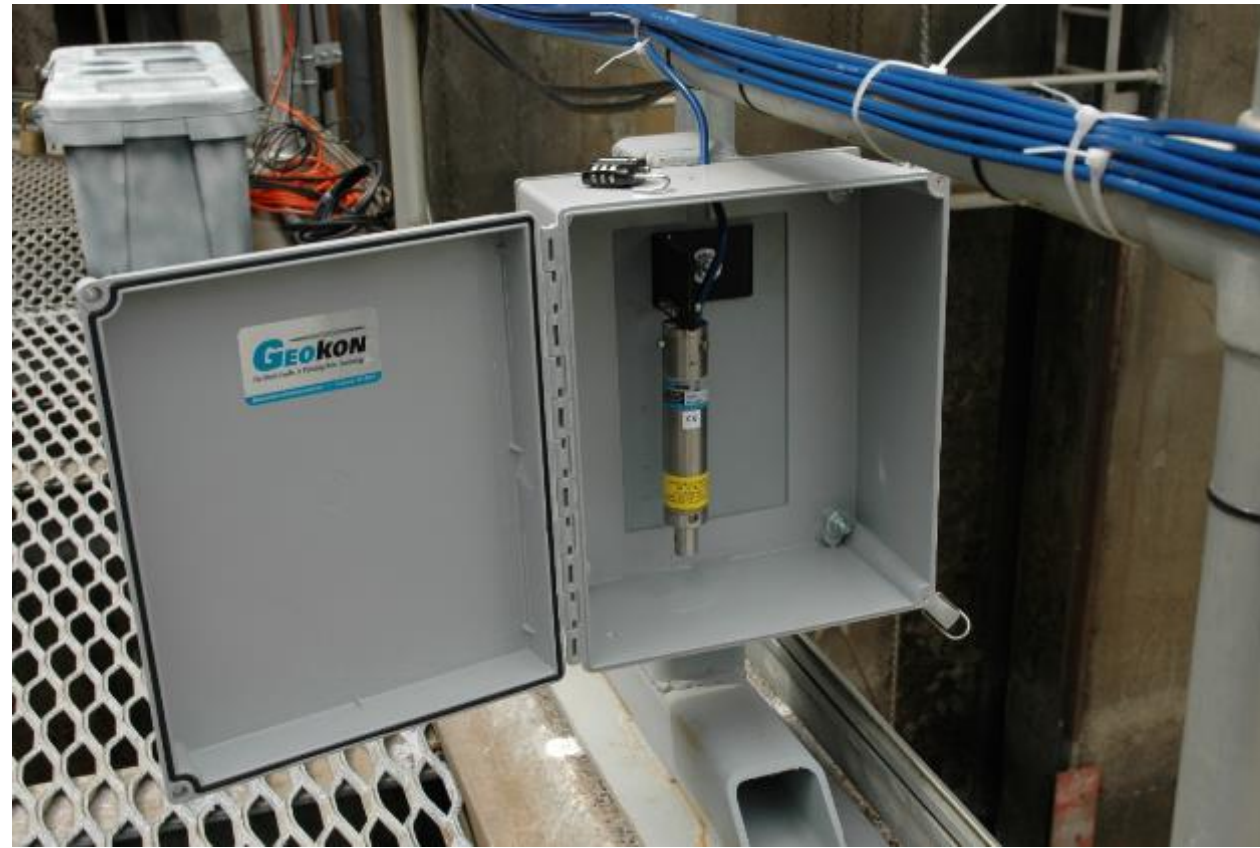
- Structural actions monitoring
  - Installation of crack & tilt meters, air & water temperature recorders, piezometric pressure monitor
  - Initial 12-month study allowed for a full range of climatic and river level conditions
  - Data collection showed how dynamic the structure movement is under changing conditions

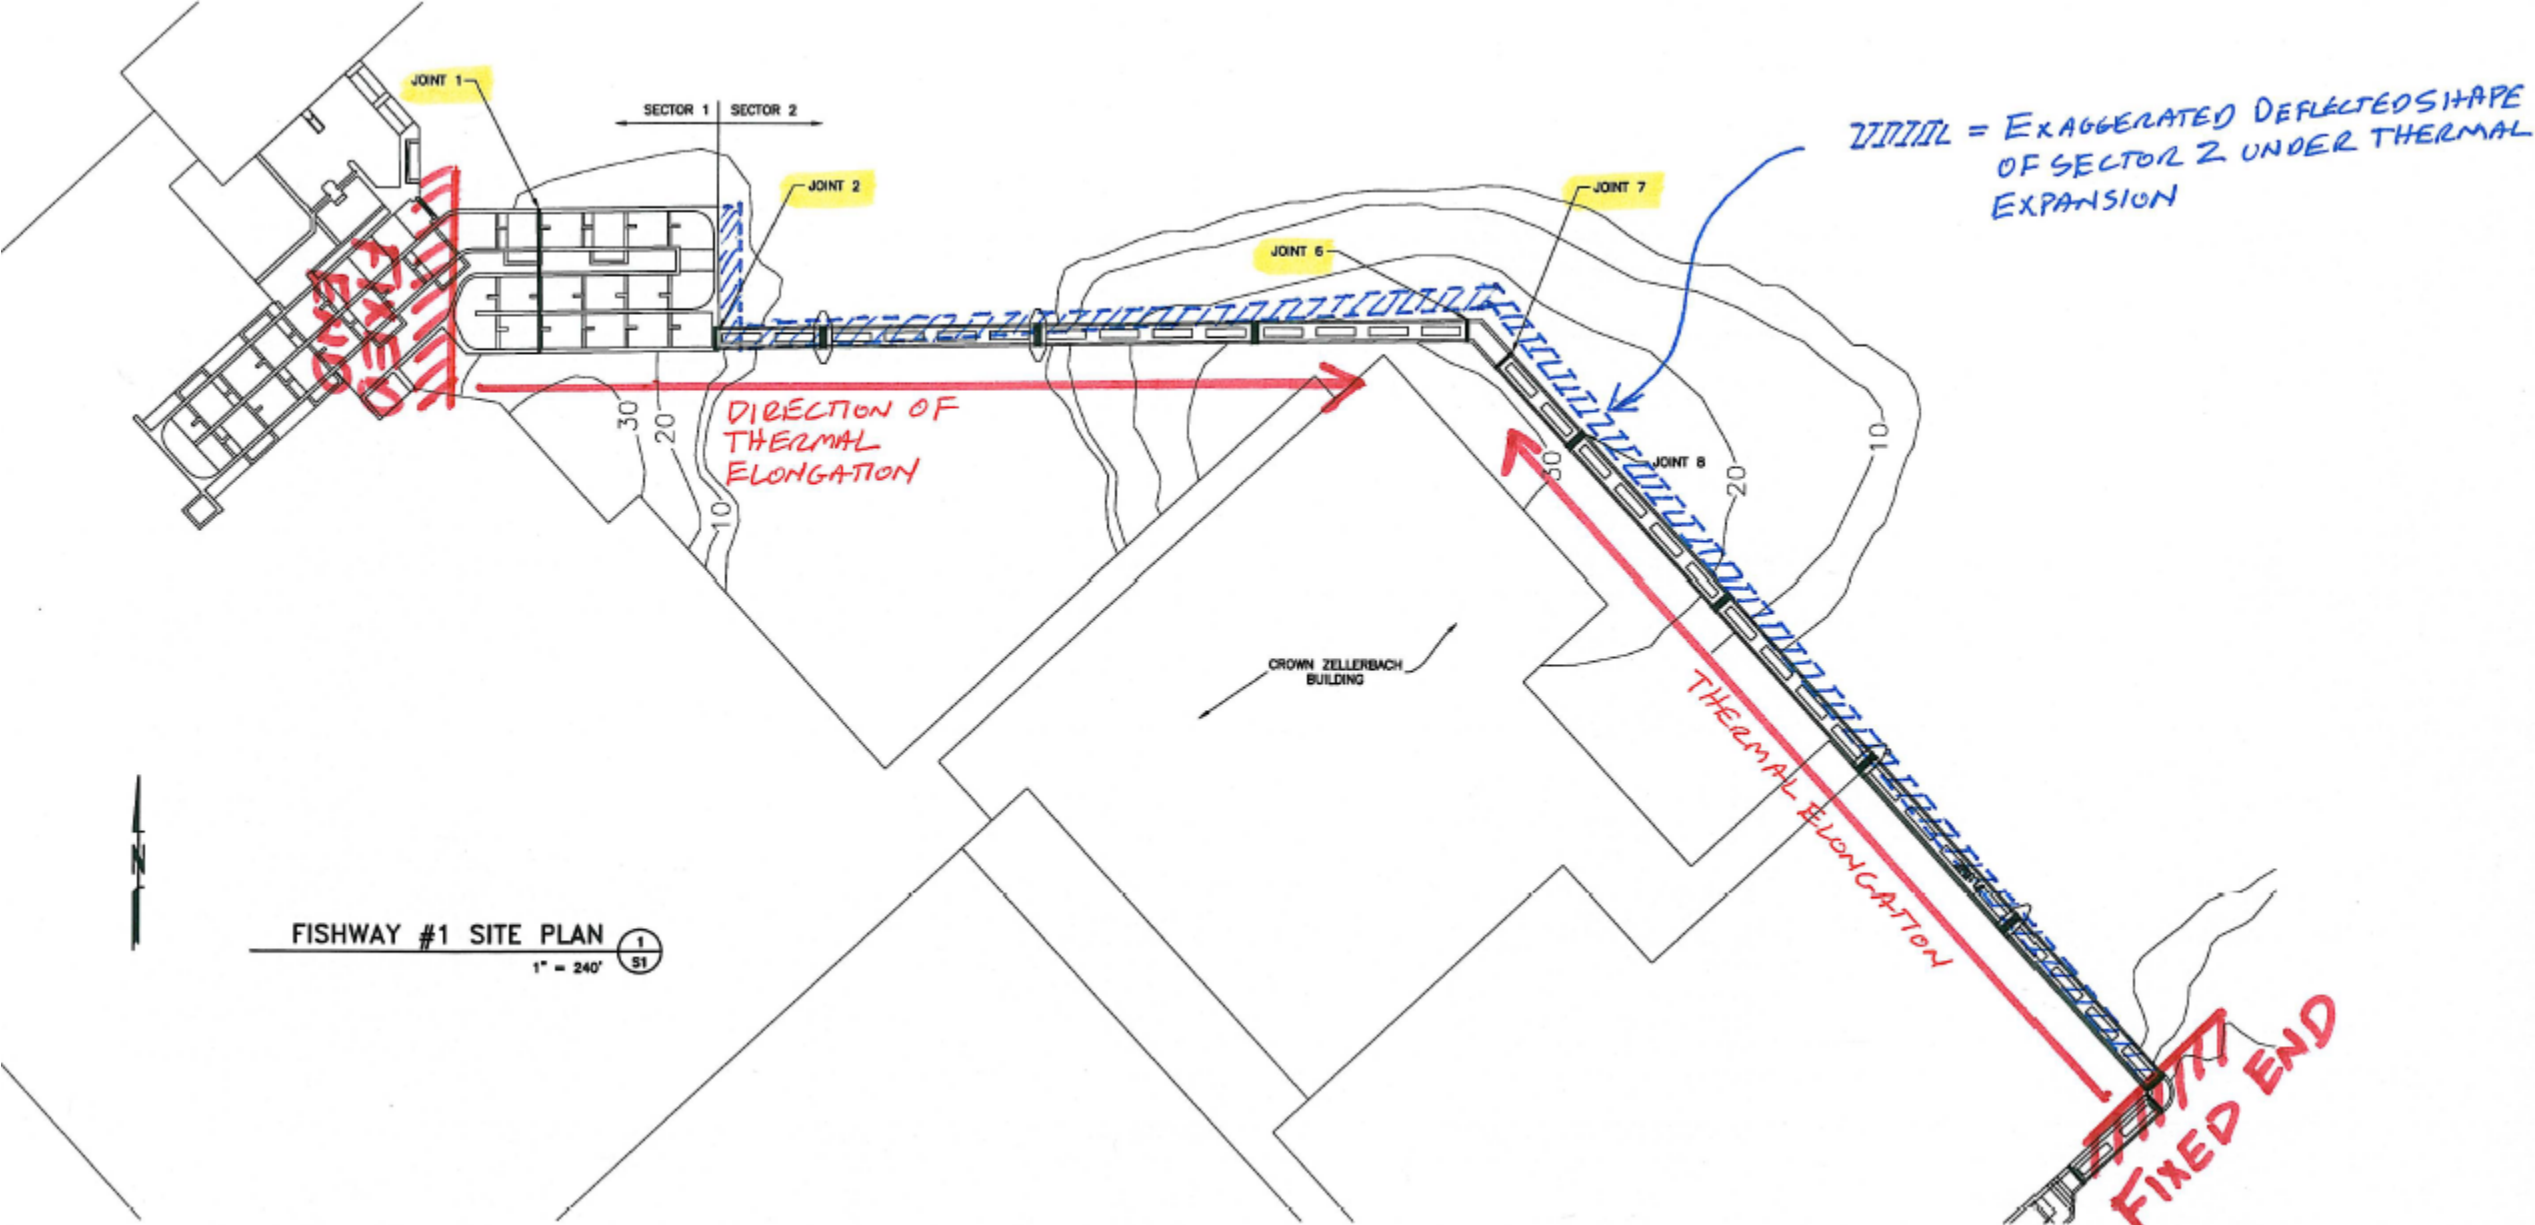
FISHWAY #1 SITE PLAN 1  
51  
1" = 240'

- Foundation Undermining
  - Additional armoring required to protect from scour
  - Installation of additional gravity support elements
- Thermal Actions Mitigation
  - Continued expansion of joint 1 caused by “fixed” ends of fishway structure
  - Lack of return force caused permanent deflections
  - Compression from thermal forces causing significant stresses in the structure and damage

- Foundation Repairs
  - Emergency installation of gabion baskets
  - Installation of grouted pin piles at joint 6/7
  - Repair of damaged joints and leak repairs
  - Encasement of foundation repairs
- Thermal Actions Mitigation
  - Releasing joints at key locations to allow for thermal expansion
  - Installation of pre-tensioned thermal force return system
