# Willamette Falls Fishway

THERMAL ACTION MITIGATION

PETERSON STRUCTURAL ENGINEERS

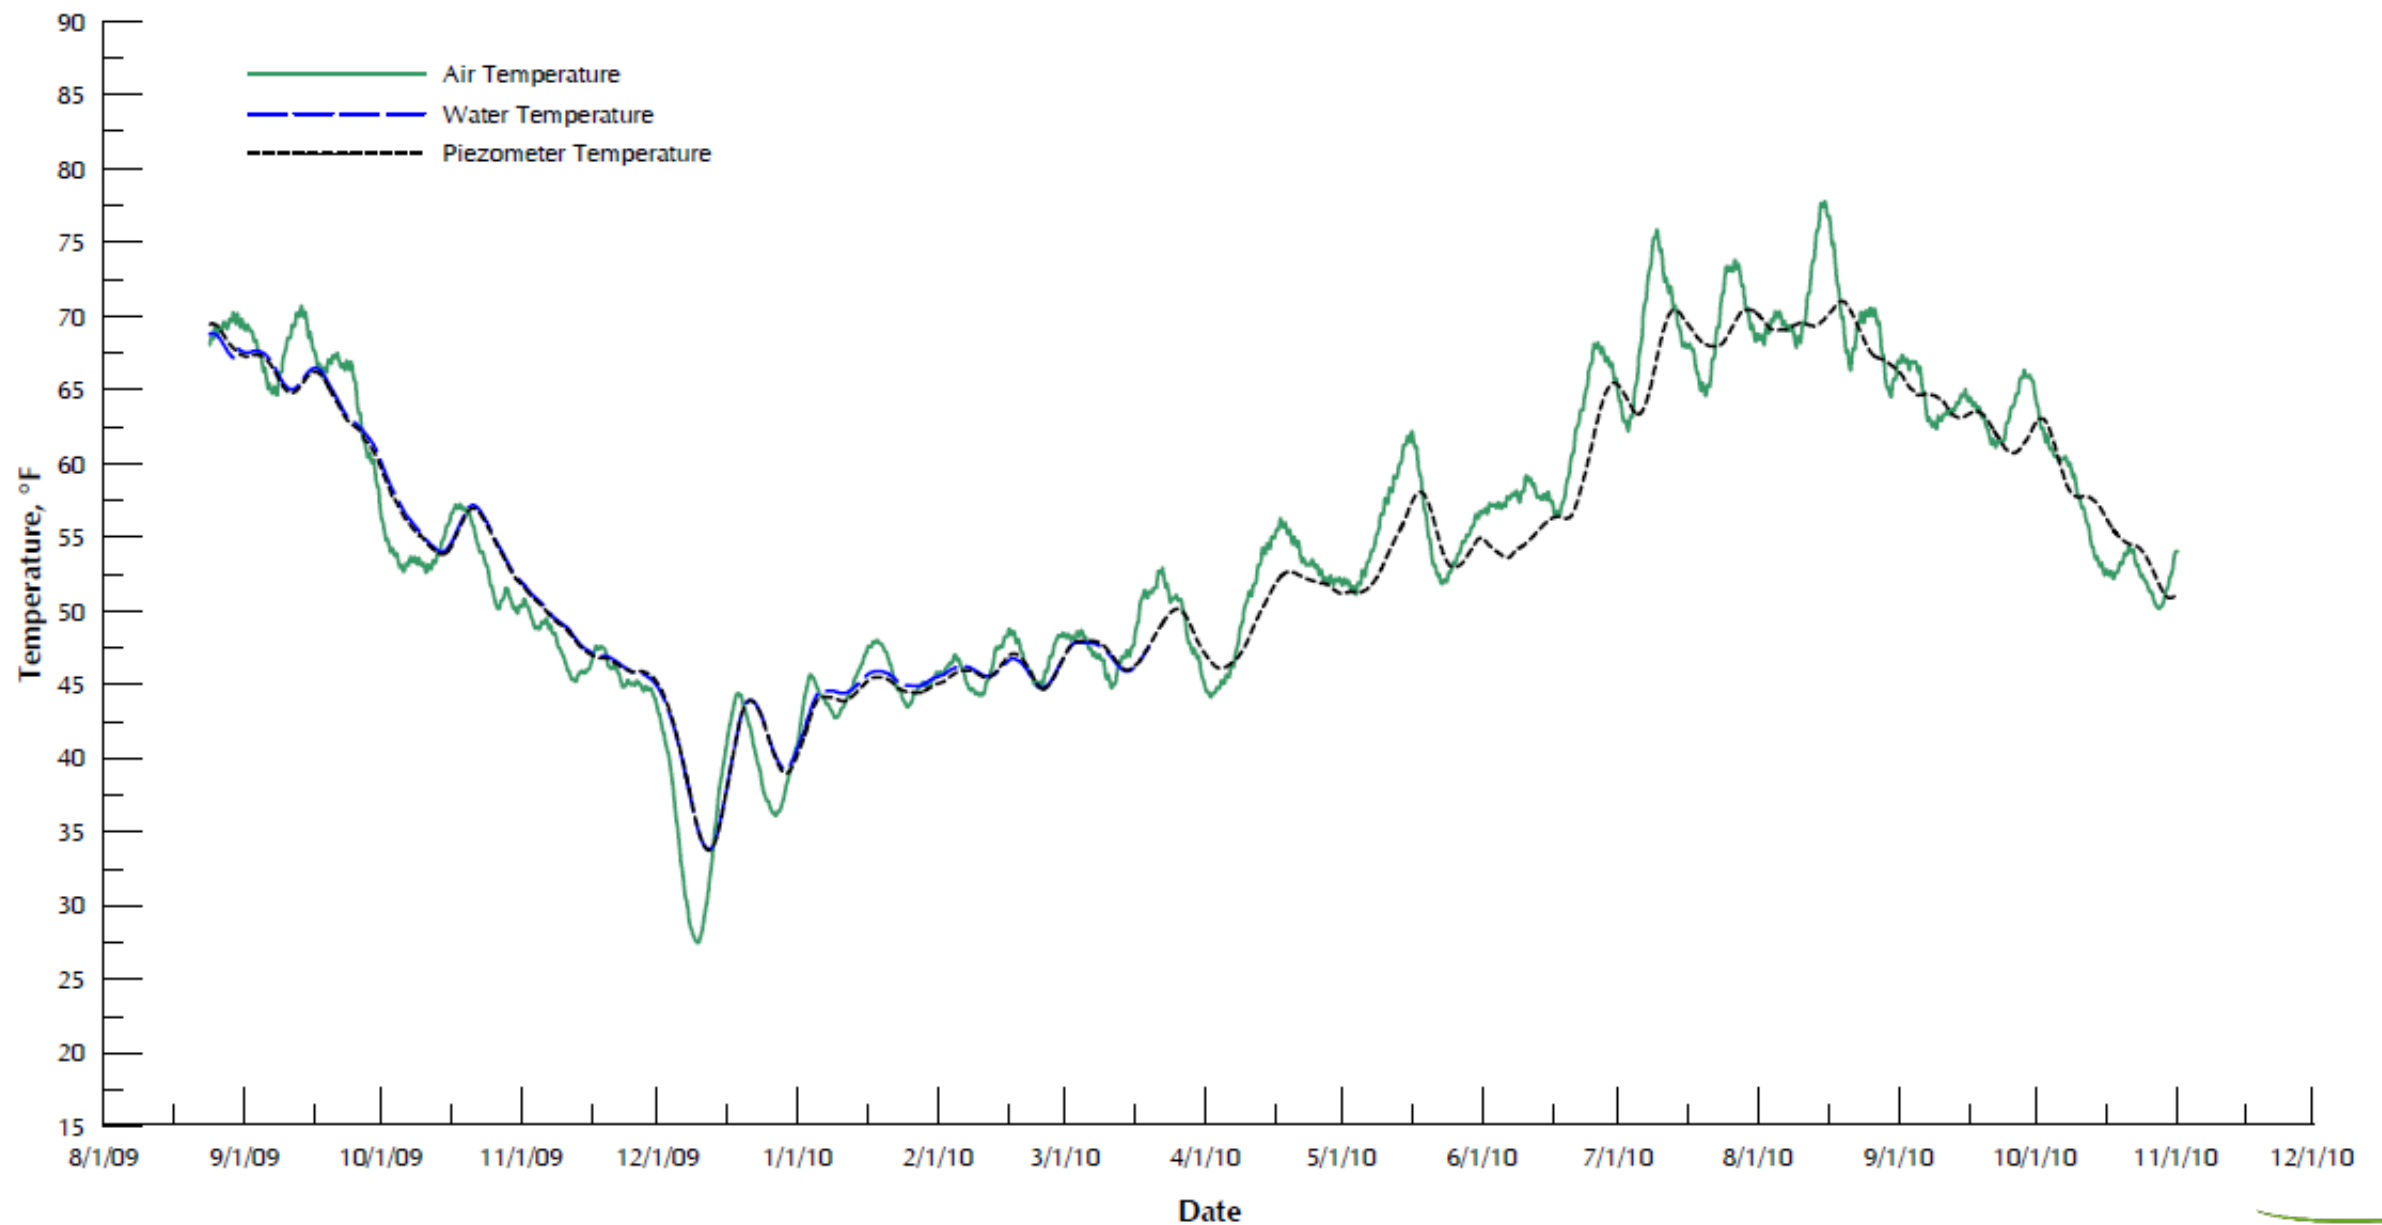
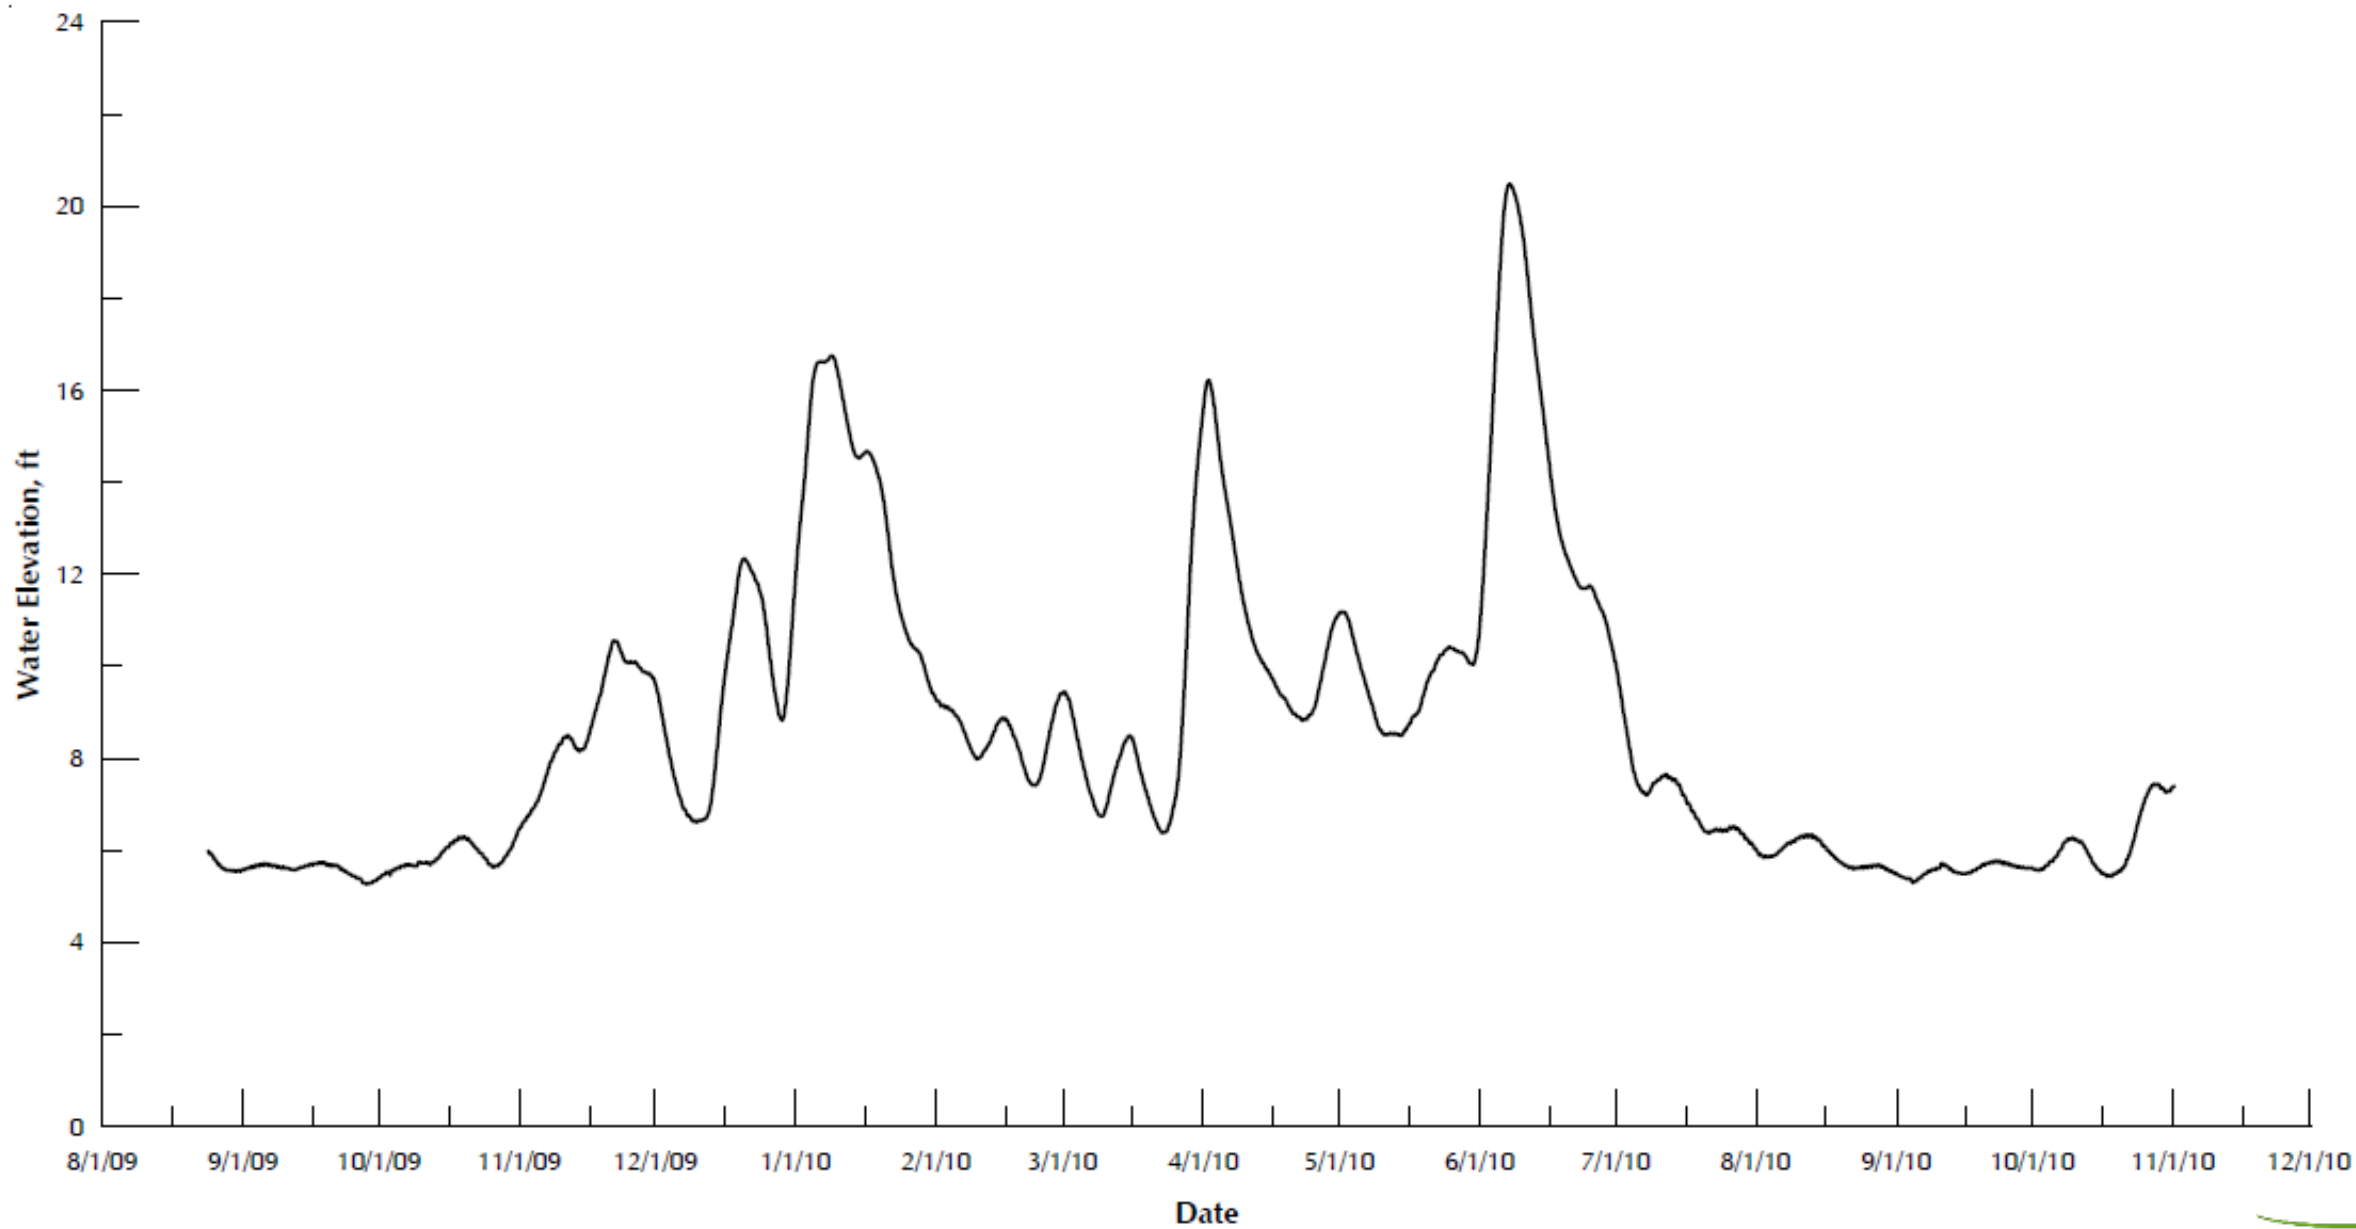
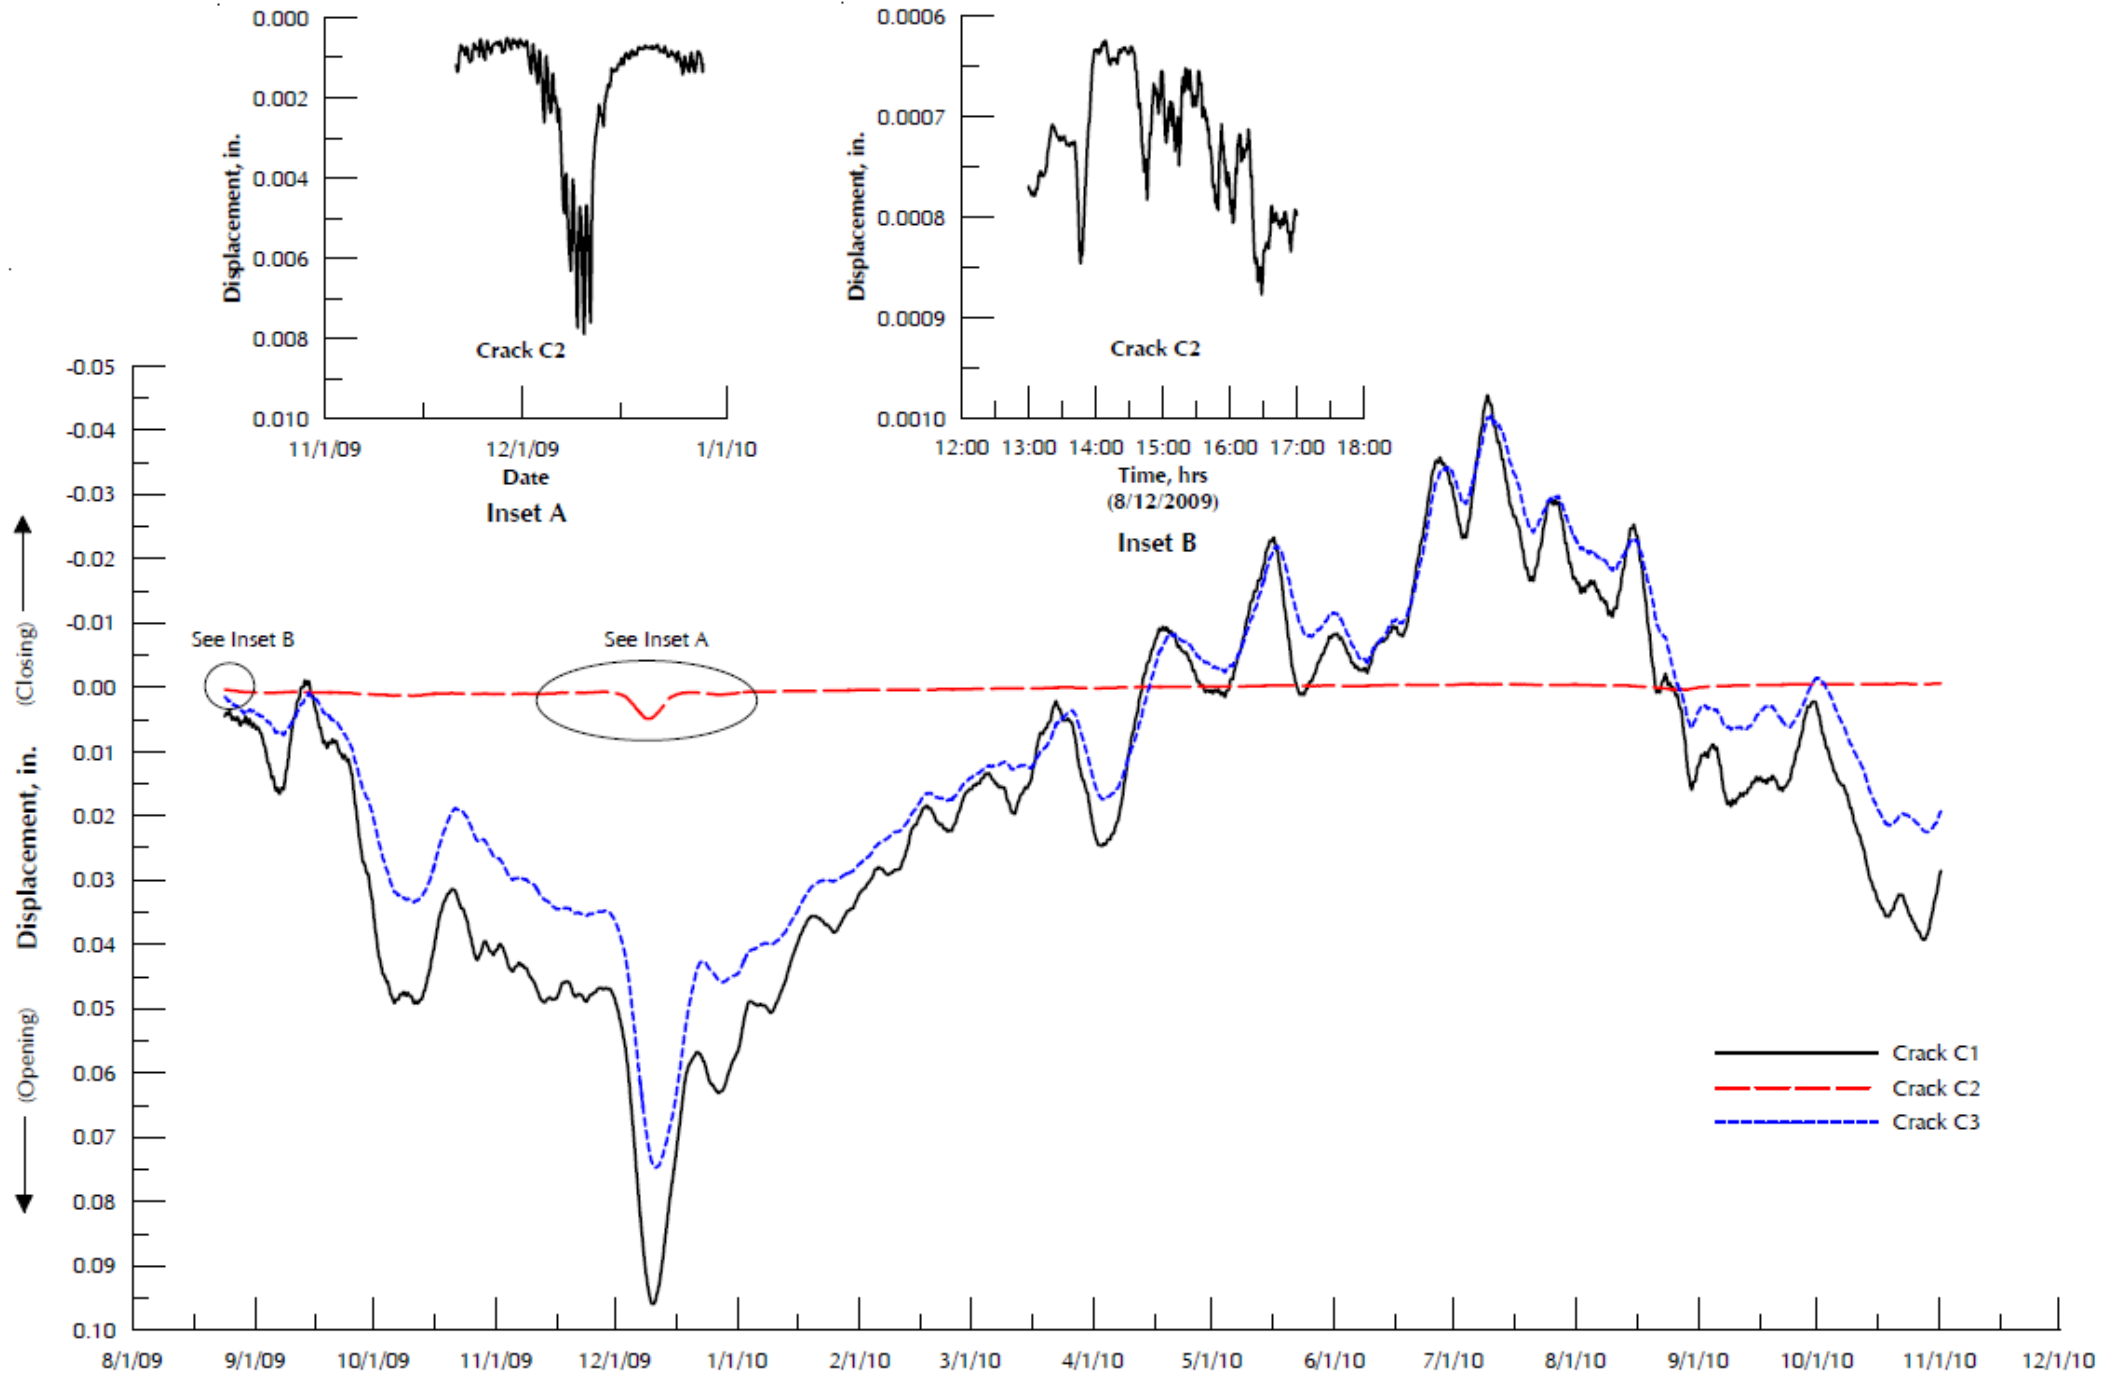
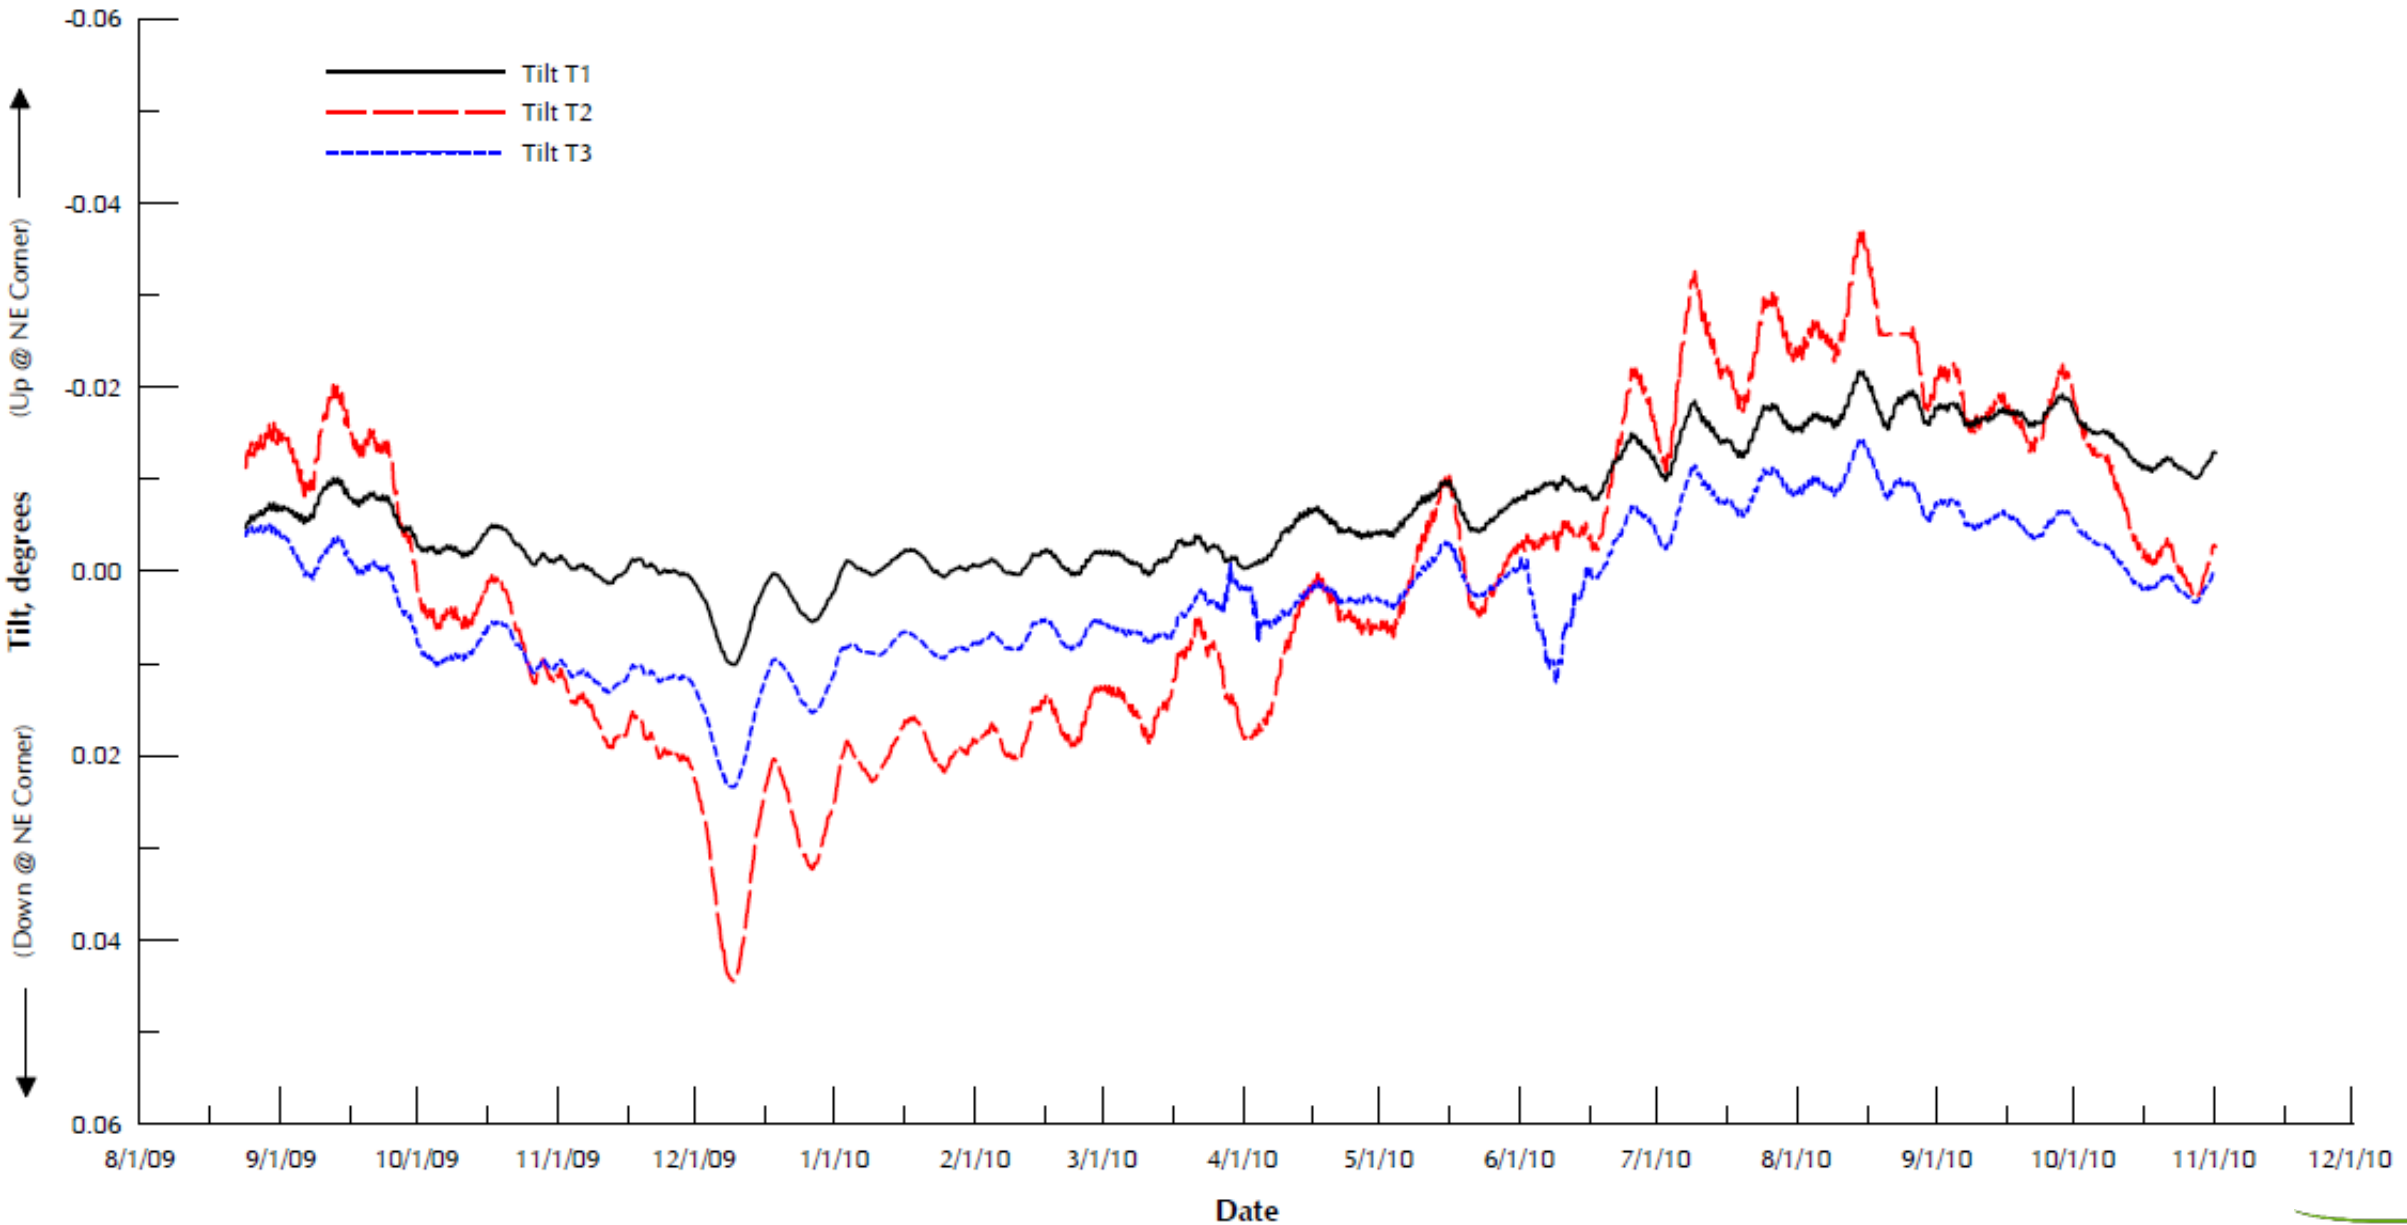
- Structural actions monitoring
  - Installation of crack & tilt meters, air & water temperature recorders, piezometric pressure monitor
  - Initial 12-month study allowed for a full range of climatic and river level conditions
  - Data collection showed how dynamic the structure movement is under changing conditions

- Foundation Undermining
  - Additional armoring required to protect from scour
  - Installation of additional gravity support elements
- Thermal Actions Mitigation
  - Continued expansion of joint 1 caused by “fixed” ends of fishway structure
  - Lack of return force caused permanent deflections
  - Compression from thermal forces causing significant stresses in the structure and damage
